Road and Railroad Crossing Inventory

Starkweather Coulee

U.S. Department of the Interior
Bureau of Reclamation
Great Plains Region
Dakotas Area Office

October 2004

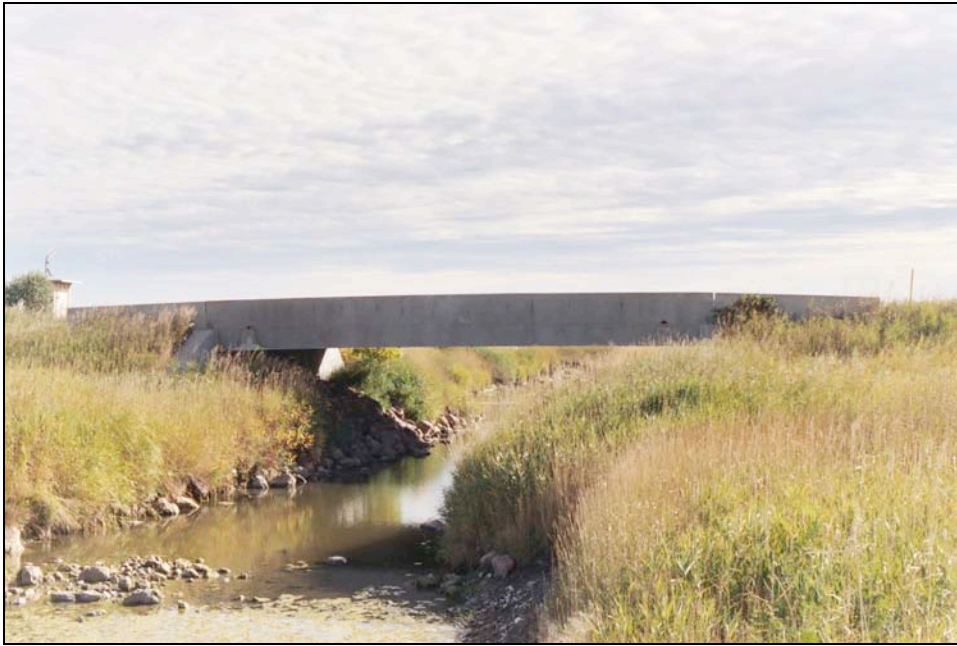
S2 Upstream side of concrete bridge, in good condition, 1.4 feet of water (09-21-04), Section 19 & 24, T156N, R64 & 65W, N 485447.68, E 2379442.35, coulee bottom elevation 1447.5 @ C/L of bridge.

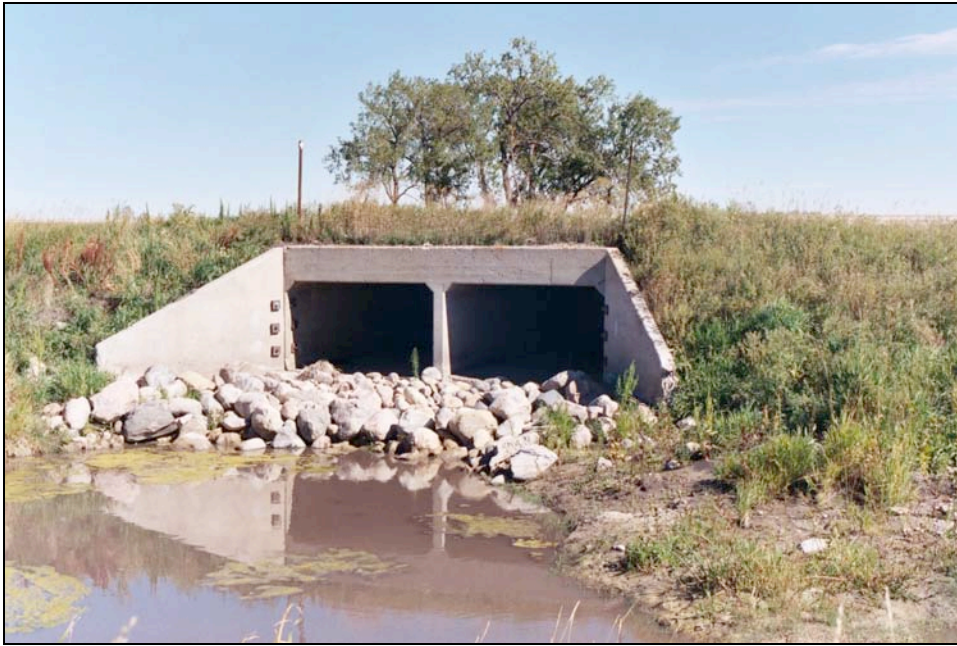
S4 Upstream side of double cell 6' foot box culvert, in good condition, no water (09-21-04), Section 9 & 10, T156N, R64W, N 496013.34, E 2394640.13, coulee bottom elevation 1460.4 @ C/L of box.

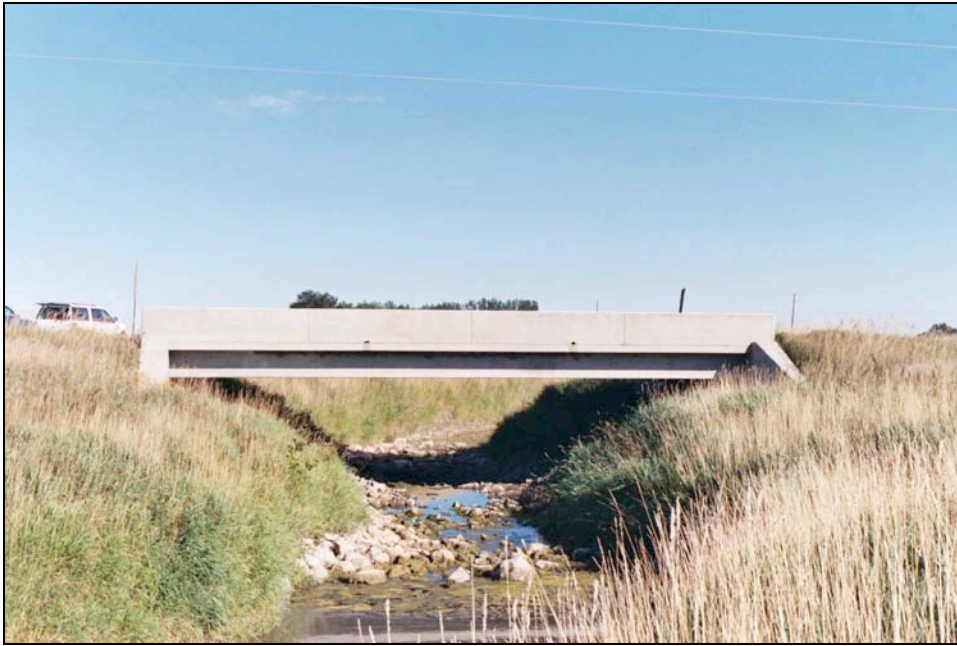
S6 Upstream side of concrete bridge, in good condition, no water (09-21-04),
Section 11 & 12, T156N, R64W, N 493198.62, E 2405519.20, coulee bottom
Elevation 1460.5 @ C/L of bridge.

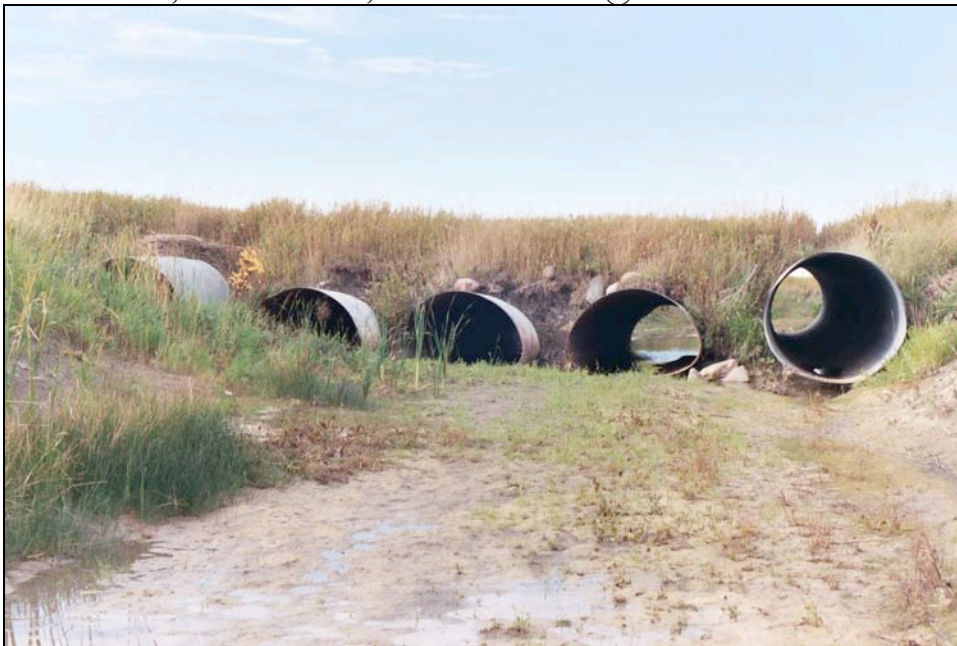
S7 Upstream side of 5 CMPs in good condition, , 72", 60", 60", 60", & 72",
 CMPs no water, 0.2 feet, 0.3 feet, 0.2 feet, no water, from west to east
 (09-21-04), Section 13 & 24, T156N, R64W,
 N 487921.49, E 2409593.46, elevation 1461.3 @ invert of 72" CMP,
 N 487926.42, E 2409601.81, elevation 1461.0 @ invert of 60" CMP,
 N 487927.30, E 2409610.25, elevation 1461.0 @ invert of 60" CMP,
 N 487927.67, E 2409619.31, elevation 1461.1 @ invert of 60", CMP,
 N 487919.01, E 2409629.59, elevation 1461.8 @ invert of 72" CMP.

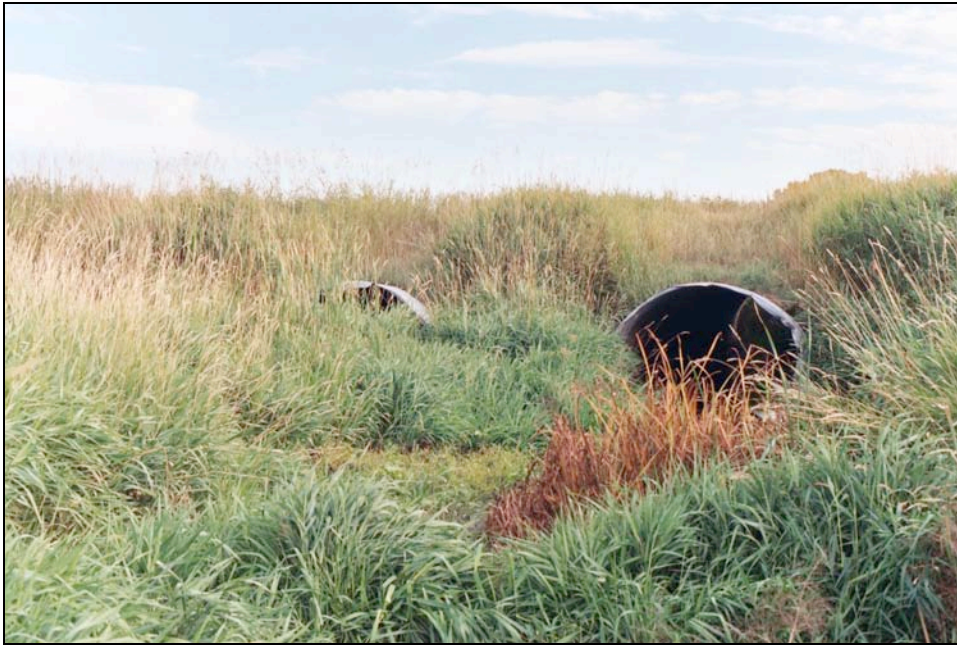
S8 Upstream side of 3 CMPs in fair condition, 60", 48", & 48" CMPs,
 0.1 feet, 0.9 feet, & 0.6 feet of water, from west to east (09-21-04),
 Section 24 & 25, T156N, R64W,
 N 482611.92, E 2408969.57, elevation 1463.2 @ invert of 60" CMP,
 N 482612.49, E 2408982.12, elevation 1462.8 @ invert of 48" CMP,
 N 482613.86, E 2408996.30, elevation 1463.2 @ invert of 48" CMP.

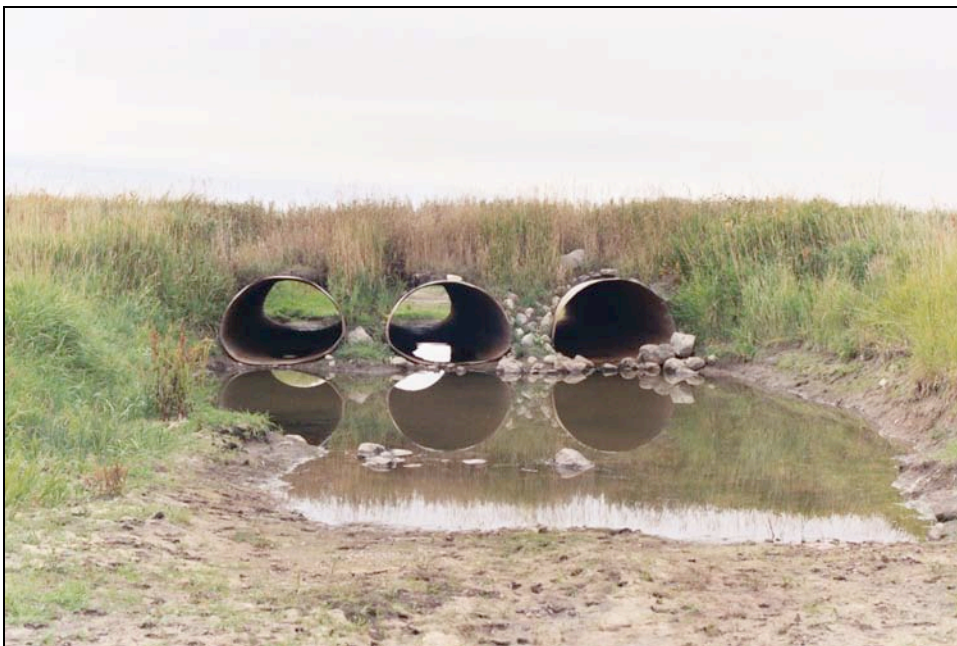
S9 Upstream side of three 60" CMPs, in fair condition, no water, from west to east (09-22-04), Section 7 & 18, T156N, R63W,
 N 488040.11, E 2412617.55, elevation 1464.0 @ invert of 60" CMP,
 N 488040.05, E 2412626.74, elevation 1464.1 @ invert of 60" CMP,
 N 488040.55, E 2412636.14, elevation 1463.9 @ invert of 60" CMP.

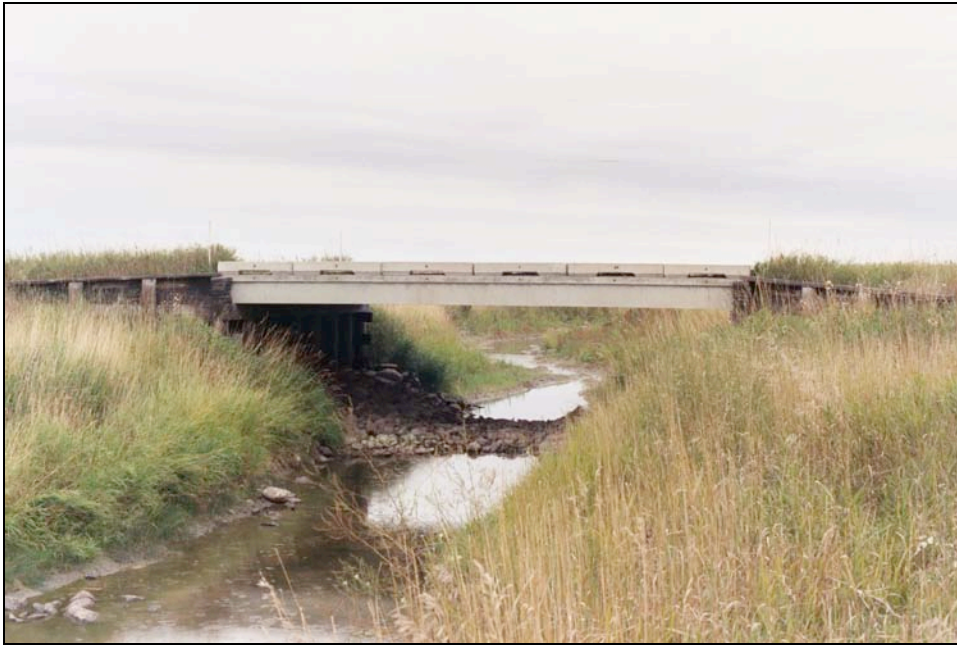
S10 Upstream side of wood & concrete bridge, in fair condition, 0.9 feet of Water (90-22-04), Section 7 & 18, T156N, R63W, N 493361.07, E 2414285.82, coulee bottom elevation 1465.0 @ center of coulee.

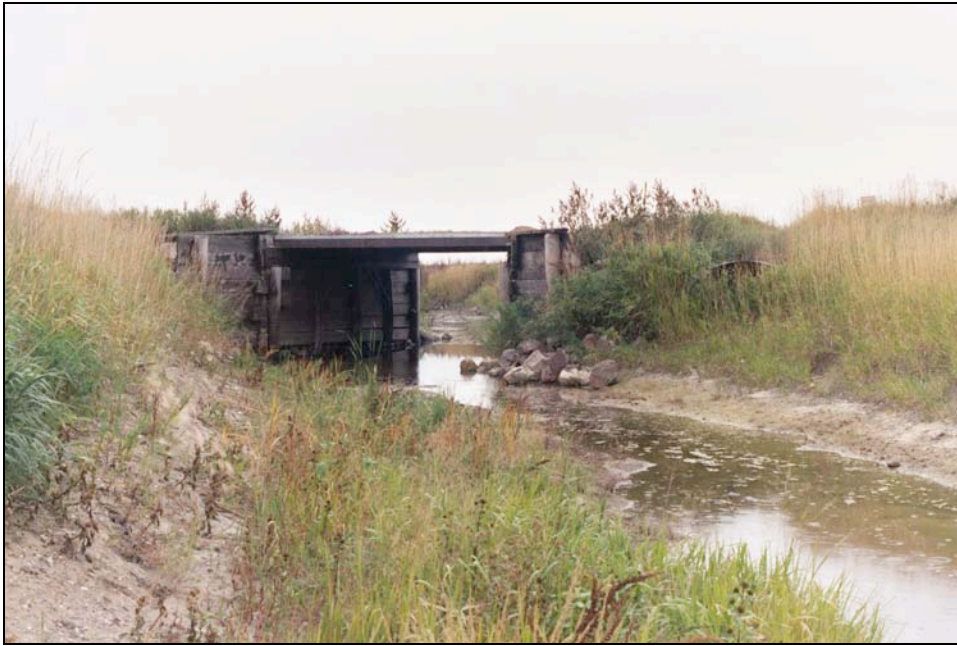
S10 Center of wood & concrete bridge, looking west in fair condition, 30.2 feet wide & 36.0 feet wide (09-22-04), Section 7 & 18, T156N, R63W, N 493346.42, E 2414289.32, elevation 1477.7 @ C/L of bridge, top of concrete.

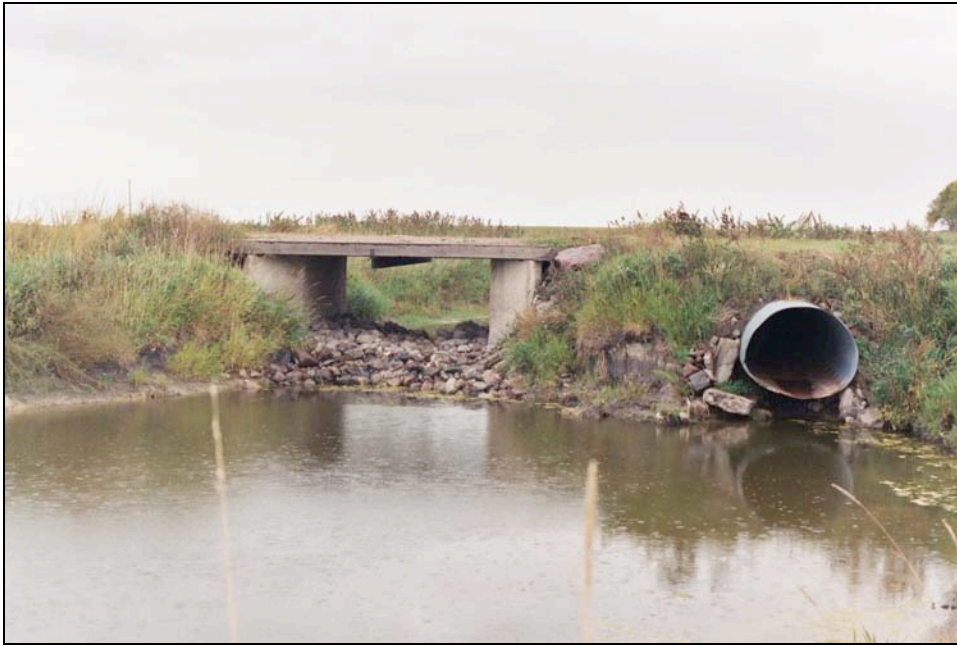
S12 Upstream side of wood & concrete bridge, with one 72" CMP, in fair condition, 2.0 feet, no water & no water (09-22-04) west to east, Section 5 & 8 T156N, R63W, N 498749.55, E 2417938.43, coulee bottom elevation 1468.7 @ C/L of bridge, N 498765.50, E 2417963.41, elevation 1470.1 @ invert of CMP.

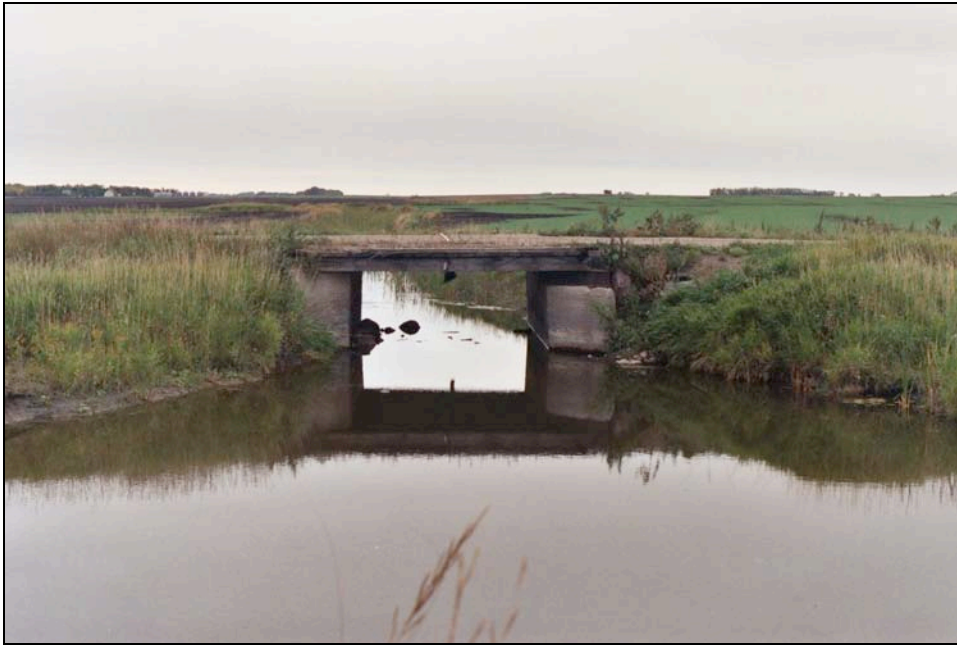
S14 Upstream side of wood & concrete bridge, in poor condition, 2.4 feet of Water (09-23-04), Section 28 & 33, T157N, R63W, N 509761.02, E 2417308.66, coulee bottom elevation 1472.3 @ C/L of bridge.

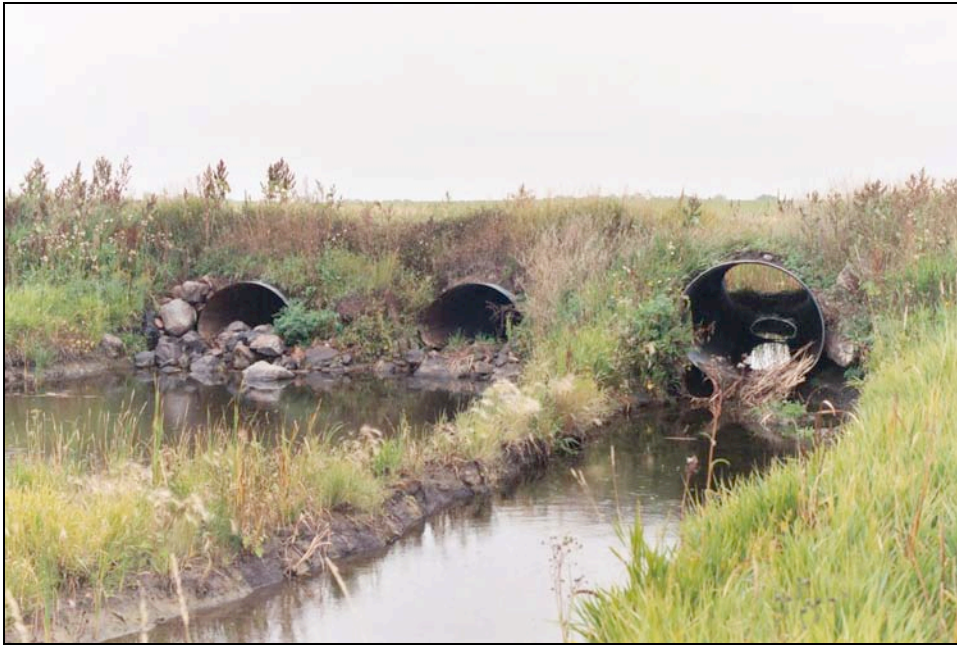
S16 Upstream side in one 72" & two 48" CMPs, in fair condition, no water, no water,
 & no water, from south to north (09-23-04), Section 21 & 22, T157N, R63W,
 N 515699.49, E 2419031.30, elevation 1478.8 @ invert of 72" CMP,
 N 515709.56, E 2419022.63, elevation 1477.7 @ invert of 48" CMP,
 N 515723.49, E 2419021.37, elevation 1477.4 @ invert of 48" CMP.

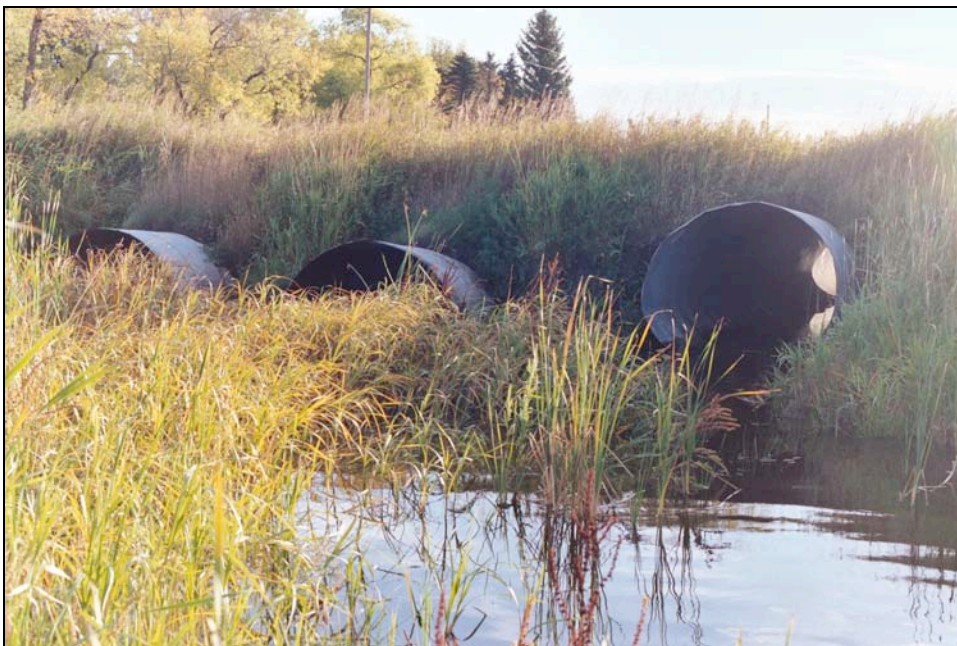
S17 Upstream side of three 60" CMPs, in good condition, 0.3 feet, 1.0 feet, & 1.3 feet of water, from south to north (09-24-04), Section 21 & 22, T157N, R63W, N 518986.54, E 2418924.32, elevation 1479.8 @ invert of 60" CMP, N 519001.02, E 2418924.67, elevation 1479.0 @ invert of 60" CMP, N 519013.99, E 2418925.40, elevation 1478.7 @ invert of 60" CMP.

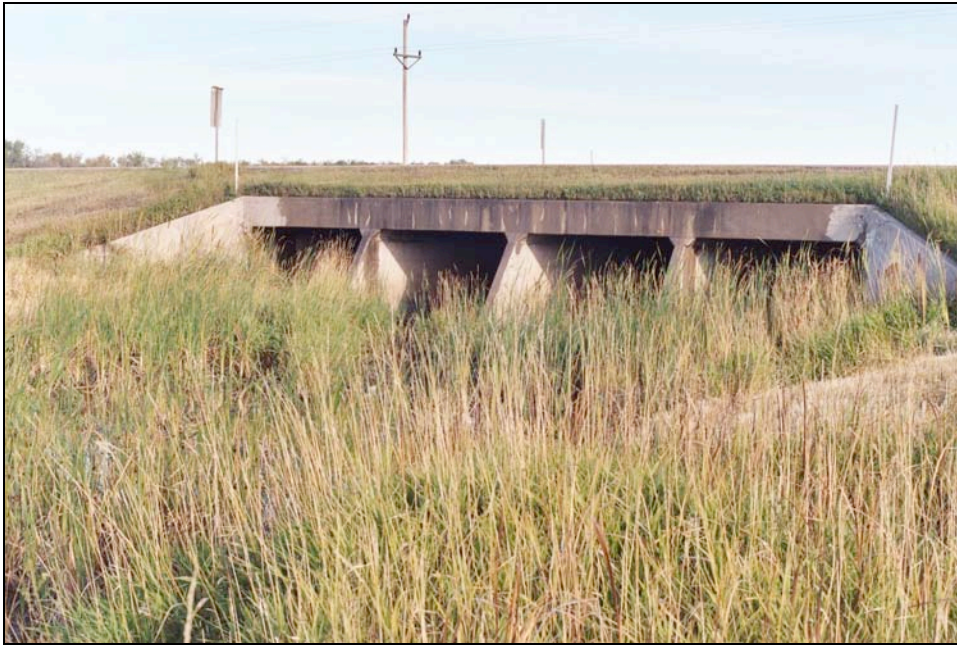
S18 Upstream side of four cell 7 foot box culvert, in good condition (09-24-04), Section 16 & 21, T157N, R63W, N 520346.56, E 2417422.63, box culvert elevation 1482.8 @ C/L of box culvert.

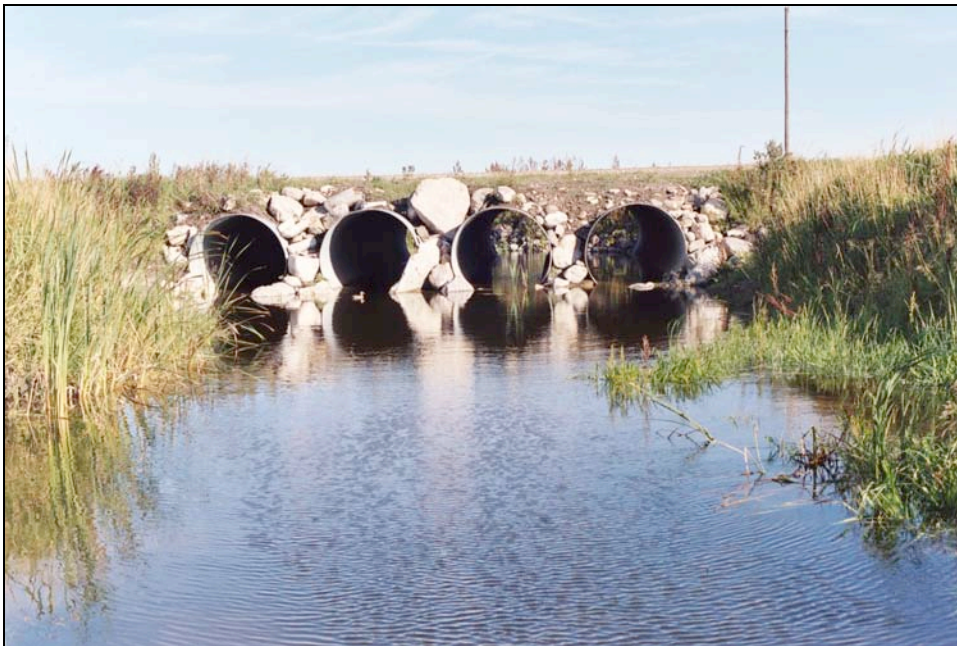
S19 Upstream side of four 72" CMPs, in good condition, 1.0 feet, 1.0 feet, 1.0, & 1.0 feet of water from east to west (09-24-04), Section 9 & 16, T157N, R63W, N 525633.66, E 2417724.00, elevation 1483.0 @ invert of 72" CMP, N 525632.54, E 2417715.83, elevation 1483.1 @ invert of 72" CMP, N 525631.22, E 2417707.82, elevation 1483.0 @ invert of 72" CMP, N 525629.71, E 2417699.73, elevation 1483.1 @ invert of 72" CMP.

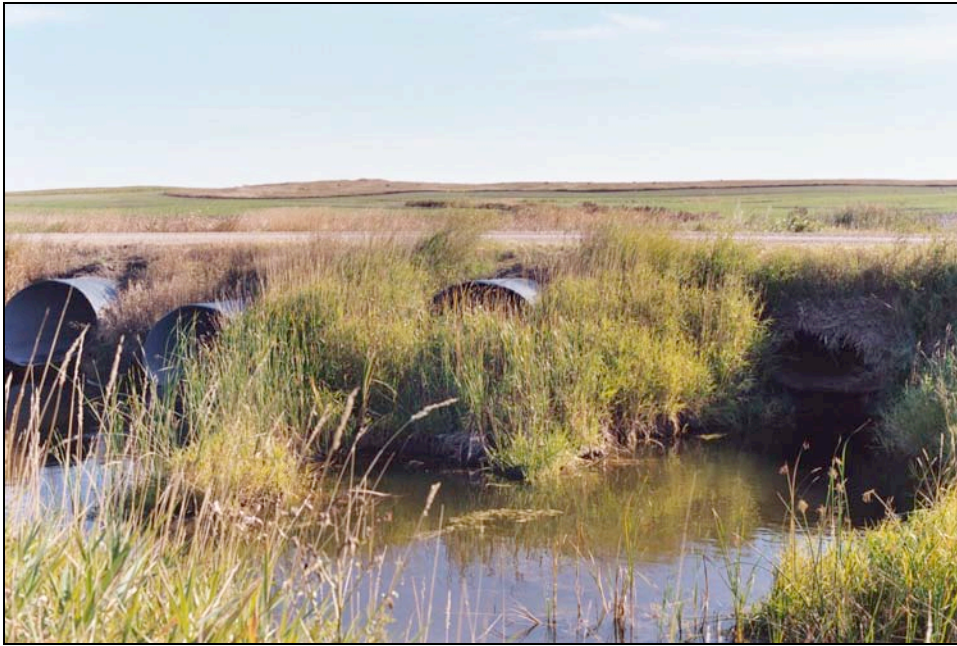
S20 Upstream side of one 48" & three 60" CMPs, in good condition,
no water, no water, 0.6 feet & no water, from south to north (09-24-04),
Section 9 & 10, T157N, R63W,
N 527185.93, E 2418803.25, elevation 1486.1 @ invert of 48" CMP,
N 527212.48, E 2418807.33, elevation 1487.6 @ invert of 60" CMP,
N 527226.06, E 2418810.37, elevation 1484.9 @ invert of 60" CMP,
N 527243.24, E 2418810.31, elevation 1486.8 @ invert of 60" CMP.

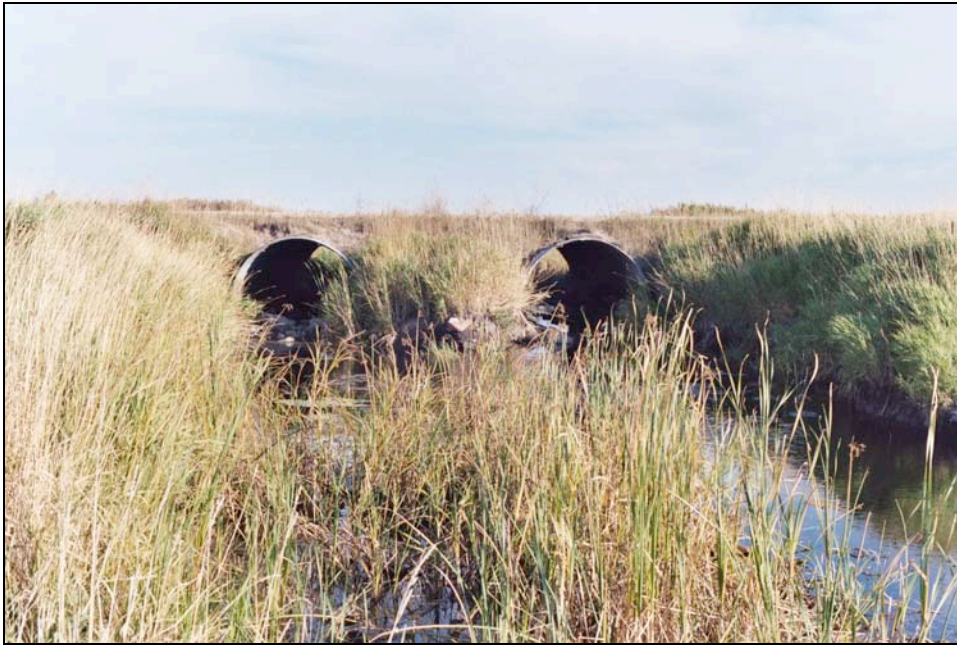
S24 Upstream side of two 72" CMPs, in good condition, 0.1 feet of water & no water, east to west (09-29-04), Section 20 & 29, T158N, R63W, N 546626.00, E 2411209.26, elevation 1502.9 @ invert of 72" CMP, N 546625.04, E 2411190.77, elevation 1503.0 @ invert of 72" CMP.

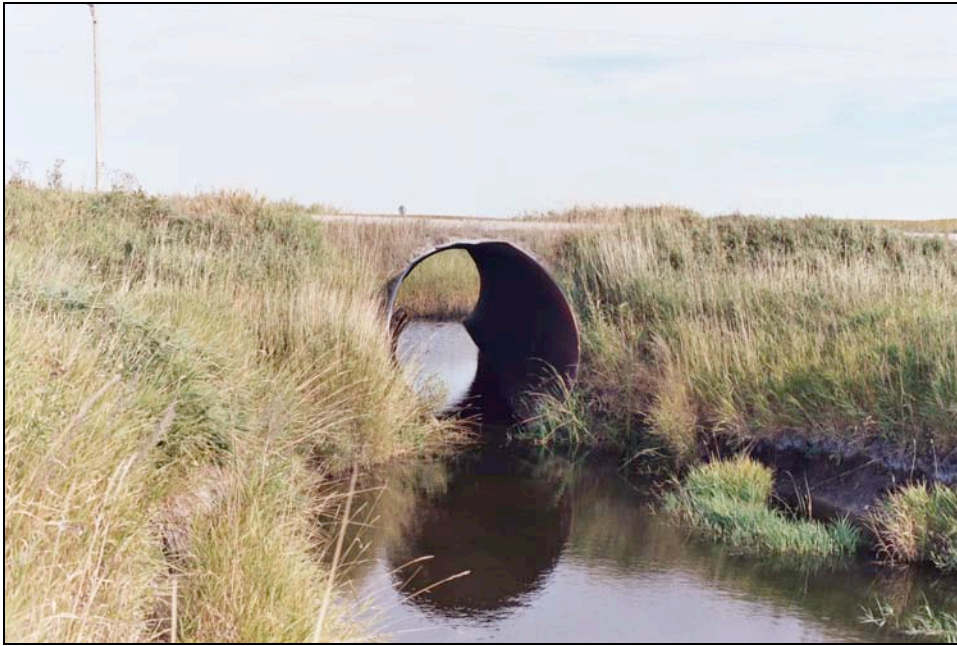
S26 Upstream side of one 120" CMP, in good condition, 0.9 feet of water (09-29-04), Section 32 & 5, T158 & 159N, R63W, N 567721.77, E 2410233.21, elevation 1529.8 @ invert of CMP.

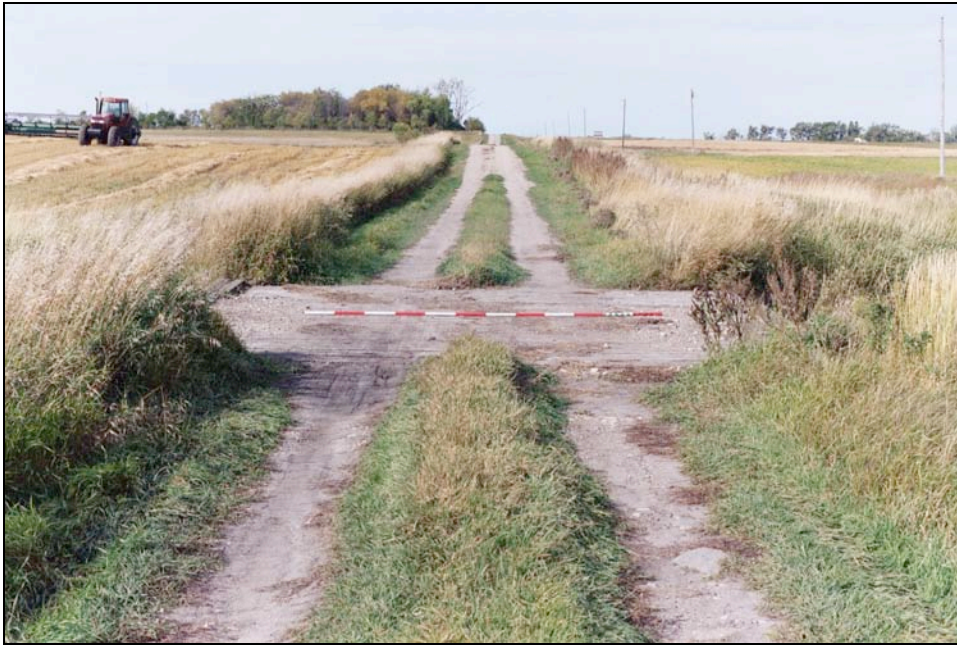
S27 Downstream side of wood & concrete bridge, in poor condition, 1.1 feet of water (09-29-04), Section 29 & 32, T159N, R63W, N 572903.94, E 2407976.76, elevation 1534.5 @ coulee bottom.

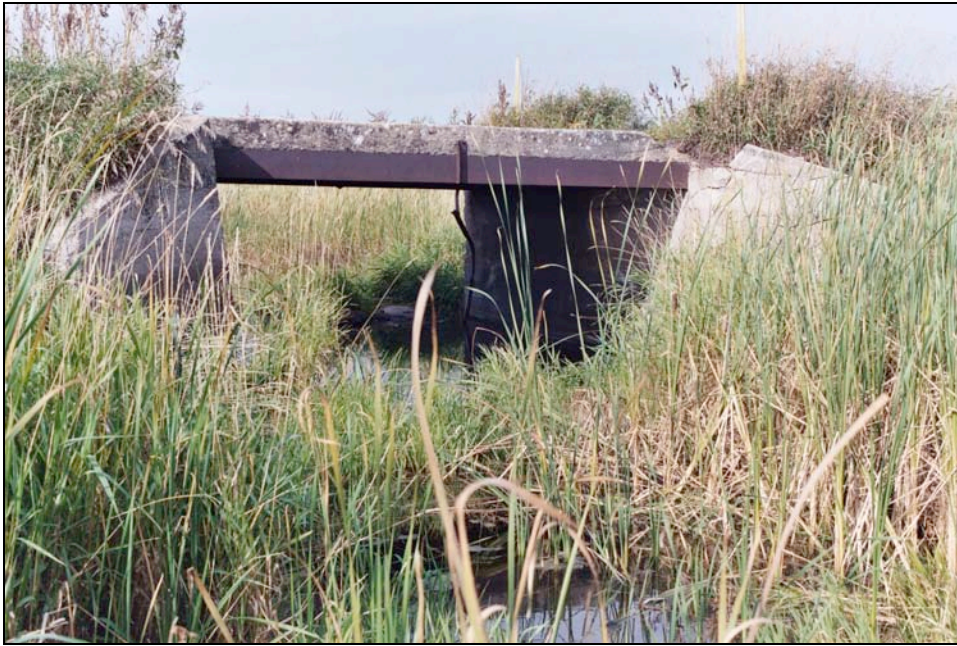
S28 Upstream side of concrete bridge, in poor condition, 0.9 feet of water (09-29-04), Section 30 & 29, T159N, R63W, N 576614.76, E 2407080.82. coulee bottom elevation 1541.6 @ C/L of bridge.

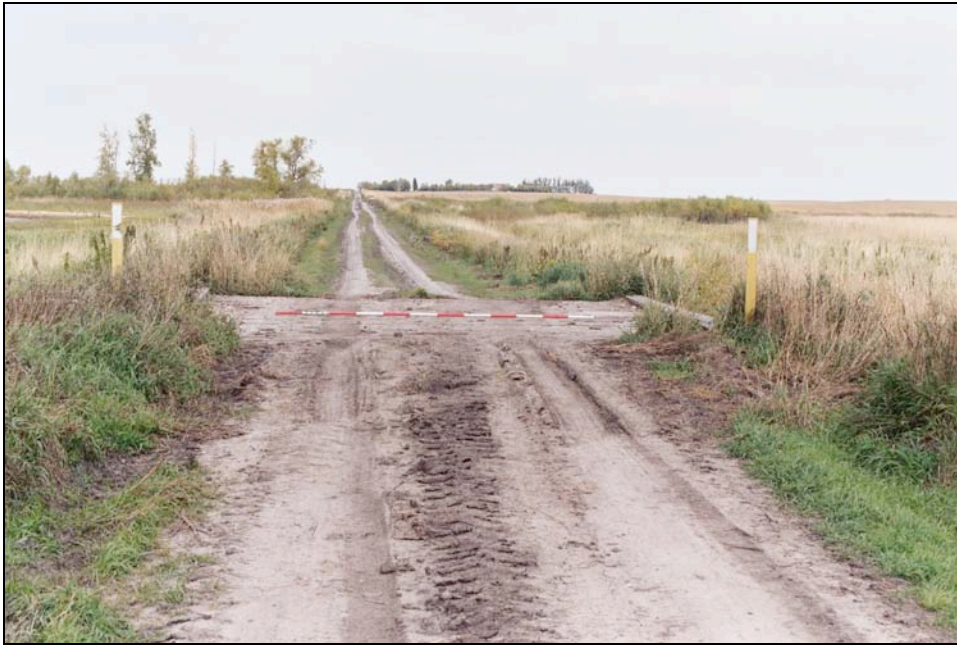
S29 Downstream side of wood & concrete bridge, in poor condition, no water (09-29-04), Section 30 & 29, T159N, R63W, N 577660.87, E 2407055.22, elevation 1544.5 @ coulee bottom.

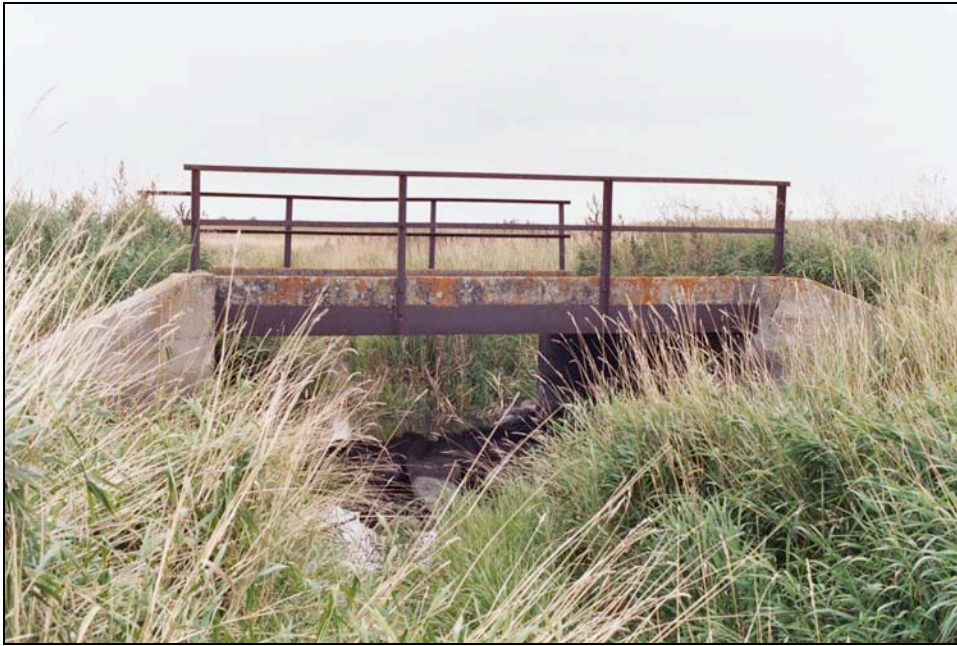
S30 Upstream side of concrete bridge, in poor condition, 0.8 feet of water (09-29-04), Section 19 & 30, T159N R63W, N 578153.63, E 2405475.61, elevation 1543.2 @ coulee bottom.

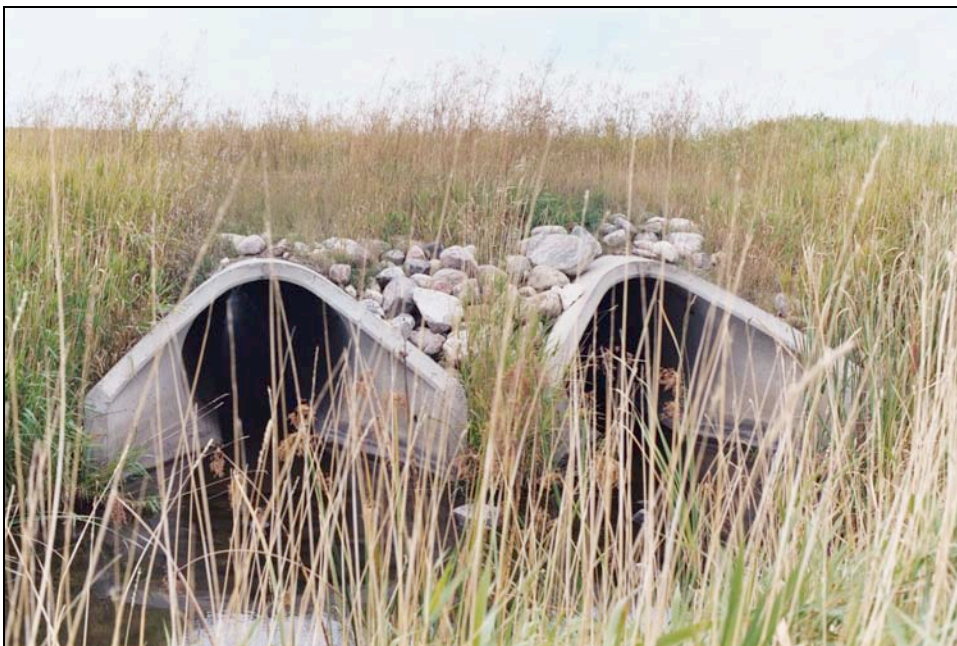
S31 Upstream side of two 60" concrete pipes, in good condition, south to north, no water @ invert of concrete pipe & 0.1 feet of water @ invert of concrete pipe (09-29-04), Section 24 & 19, T159N, R63 & 64W, N 582613.67, E 2401692.08, elevation 1551.2 @ invert of 60" concrete pipe, N 582623.80, E 2401692.80, elevation 1551.2 @ invert of 60" concrete pipe.

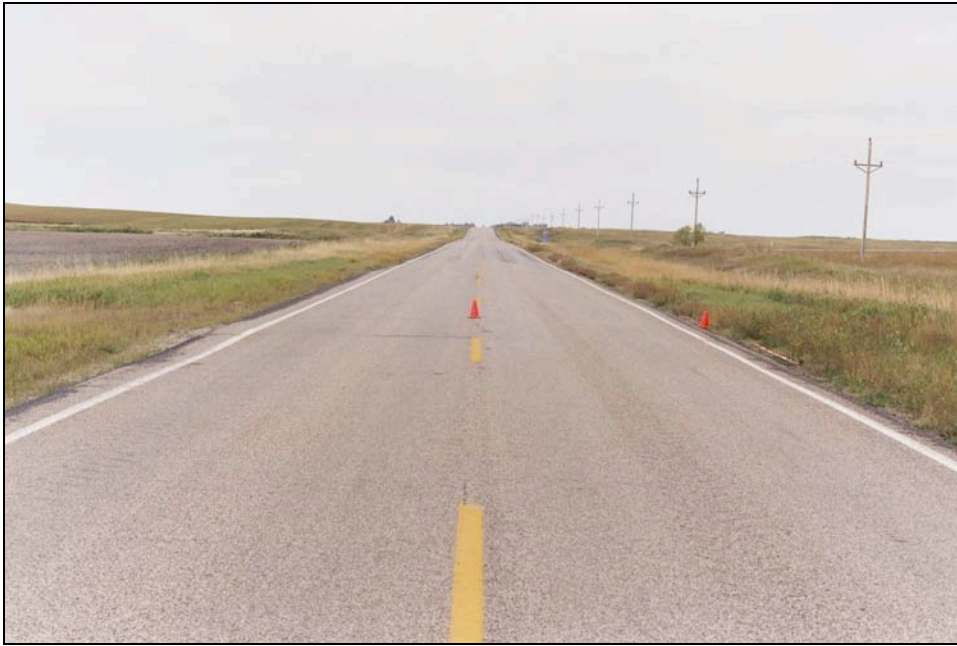
S31 Downstream side of two 60" concrete pipes, in good condition, south to north, 0.4 feet of water @ invert of concrete pipe & 0.3 feet of water @ invert of concrete pipe (09-29-04), Section 24 & 19, T159N, R63 & 64W, N 582608.54, E 2401782.19, elevation 1551.0 @ invert of concrete pipe, N 582618.27, E 2401783.07, elevation 1551.0 @ invert of concrete pipe.

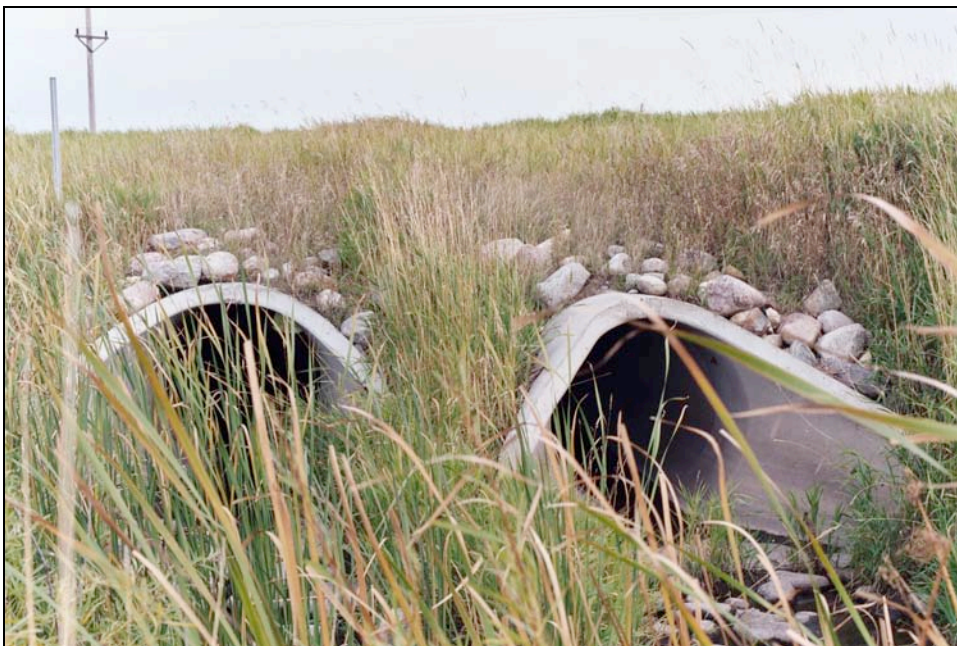
S33 Upstream side of two 60" concrete pipes, in good condition, 0.3 feet of water & 0.3 feet of water, @ invert of concrete pipes, south to north (09-29-04), Section 13 & 18, T159N, R64 & 63W, N 587871.95, E 2401665.59, elevation 1558.2 @ invert of 60" concrete pipe, N 587882.44, E 2401664.42, elevation 1558.2 @ invert of 60" concrete pipe.
